**MANDATORY BULLETIN No. EV 97 – 004a**

- 1. CONCERNING TO:** Ultralight aircraft EV-97 EUROSTAR (S/N 9700X2, 9700X3, 980101 through 990609, 20000610 through 2011012 including).
- 2. REASON :** Mismatch securing of adjusting screws of trim tab control cables.
- 3. REQUIRED ACTIONS :** Check eventually repair securing of adjusting screws.
- 4. LATEST DAY OF THE ACTION:** Immediately upon the bulletin receiving.
- 5. ACTION CARRIED OUT BY: :** Operator (owner).
- 6. COSTS COVERED BY :** Operator (owner).
- 7. NECESSARY MATERIAL :** Not required.
- 8. PROCESS :** Detailed procedure is mentioned in enclosure No. 1.
- 9. ENCLOSURE:** Enclosure No. 1 – Detailed procedure for checking and securing adjusting screws.  
Enclosure No. 2 – Changed pages of Airplane technical description, operating, maintenance and repair manual for EV-97 EUROSTAR aircraft

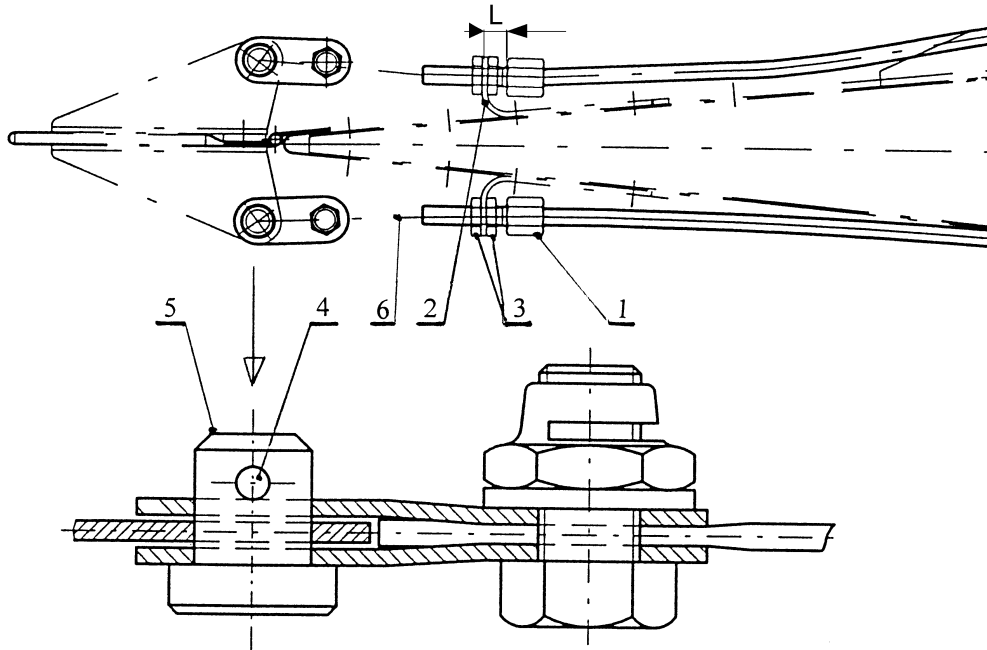
**Design „A“**

1. Check securing of adjusting screws (pos. 1) in their holders (pos. 2) attached to the elevator.  
Securing nuts (pos. 3) have to be installed according to figure (see page 2 of this enclosure – design „A“ and „B“). If both nuts are installed consecutively (on one holder side), it is necessary to repair them according to the following text).

2. Repair procedure
  - 2.1 Measure and write down the length L (between the holder and the screw head) on the top and the bottom elevator side.
  - 2.2 Design „A“ – on the top elevator side remove the safety pin (pos 4) and the pin (pos. 5) from the trim tab hole. The top and lower control cables (pos. 6) will be released by doing this.

- 2.4 Draw out adjusting screw (pos. 1) and the cable (pos. 6) from hole of the holder (pos 2). It is valid for the top and bottom side.
  - 2.5 Release nuts (pos 3) by two wrenches No. 10. Unscrew the outer nut and move it at the cable end. Put cable back into the holder hole. Put the adjusting screw into the holder hole and partially screw the outer nut back on the adjusting screw.

- 2.6 Design „A“ - connect cable to the trim hole with help of the pin (pos 5). Secure the pin by the safety pin (pos 4). Design „B“ – put the cable into the screw hole (pos. 8) and set it to the marked position. Tight the nut (pos. 7) to secure the cable.

- 2.7 Screw the nuts (pos. 3) and tight them towards holder (pos. 2). Previously measured length L (between the holder and the screw head) must be maintained both – on the top and bottom elevator side. Mark mutual position of the nuts by red paint.

- 2.8 If a loss of length L (design „A“) or marked cable position (design „B“) occurs, it is needed to perform trim tab adjustment according to the Airplane technical description, operating, maintenance and repair manual.
