**MANDATORY BULLETIN No. EV 97 – 006 a
SPORTSTAR – 001 a**

- 1. CONCERNING TO :** Elevator trim system of EV-97 and SPORTSTAR aeroplanes.
Not concerning to the aeroplanes with the electrical trim system.
- 2. REASON :** A careless preflight inspection of the elevator trim system followed by performance of a flight with the elevator trim control cables being damaged. Consequently cable breaking in-flight resulting in longitudinal oscillations of the aeroplane. Such situation has to be solved by deceleration of airspeed to 100 km/h IAS and a landing should follow as soon as possible.

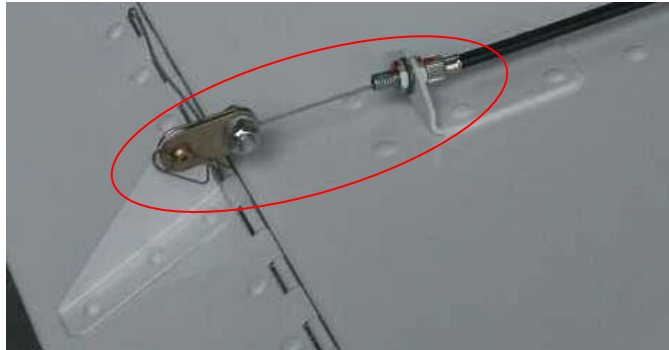
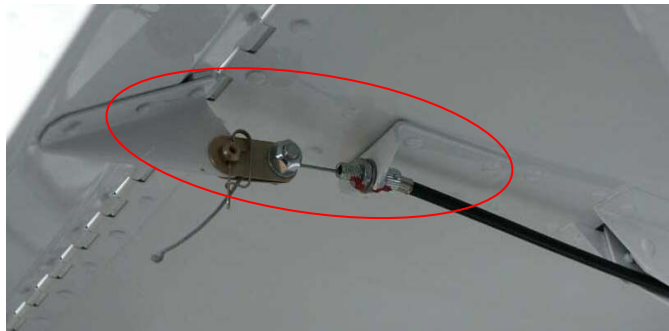
Fig. 1 Trim tab system inspection areas at preflight inspections

- 3. REQUIRED ACTION :** Thorough preflight inspections according to the Pilot Operating Handbook, Section 4, Preflight inspection.
Pay attention to condition and securing of both trim control cables at the trim tab in area marked on Fig. 1 shown in enclosure of this bulletin.
In the event of damaged cables finding contact your aeroplane dealer or aeroplane manufacturer to order a set of spare parts and work procedure.
Remove a central console cover between the seats at every 100 hour periodic inspection and visually check the condition of cables at trim control lever and securing of all joints – see Fig. 2 in enclosure.

- 4. LATEST DATE OF THE ACTION:** The trim system at the trim tab must be inspected at every preflight inspection. The damaged cables must be replaced prior to the next flight.
The inspection of trim system in the cockpit must be carried out on receipt of this bulletin (not applicable for the new aeroplanes with less than 100 total hours flown) and than at every 100 hour periodic inspection.

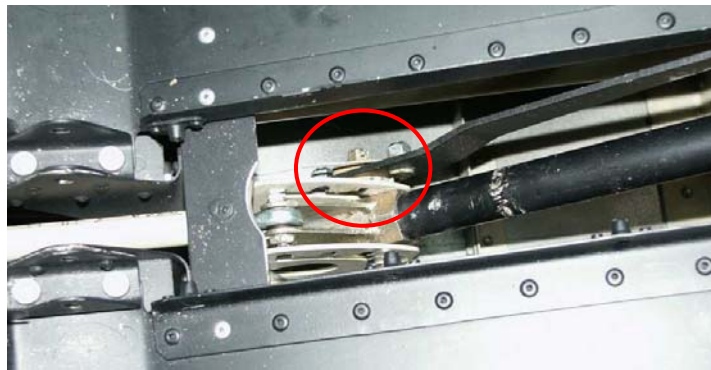
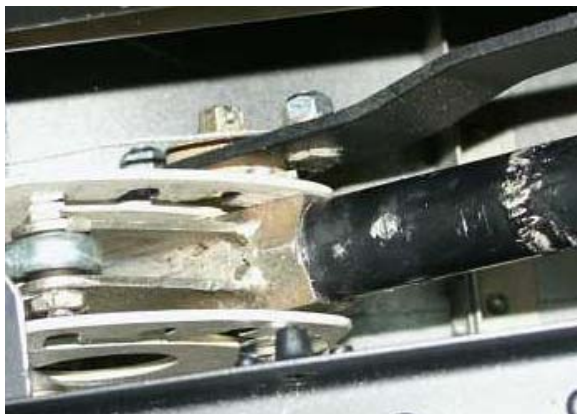
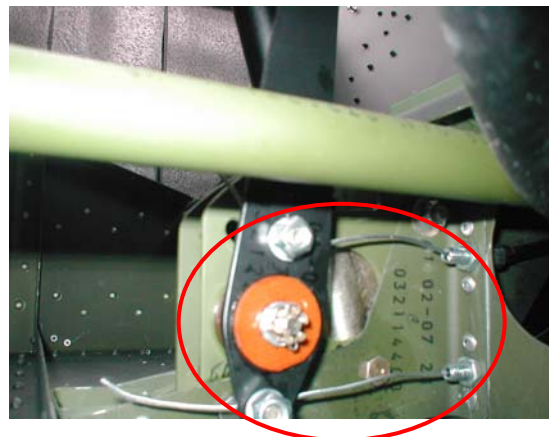
Fig. 2 Trim tab system inspection area at 100 hour periodic inspections
(Accessible after removal of central console cover between the seats)

- 7. NECESSARY MATERIAL :** Specified in the set of spare parts.
- 8. WORK PROCEDURE :** The preflight inspection actions are listed in the Pilot Operating Handbook, Section 4. Normal procedures, Preflight inspection.
A procedure to replace the cables and respective parts shall be supplied with the set of spare parts.
Removal of the central console cover between the seats at every 100 hour periodic inspection and visual check of the condition of cables at trim control lever and securing of all joints - Fig. 2 in enclosure.
